Mir Photo/TV Survey (DTO-1118): STS-84 Mission Report

Prepared by:
**Image Science and Analysis Group
Earth Science Branch
Earth Science and Solar System Exploration Division**

September 1997

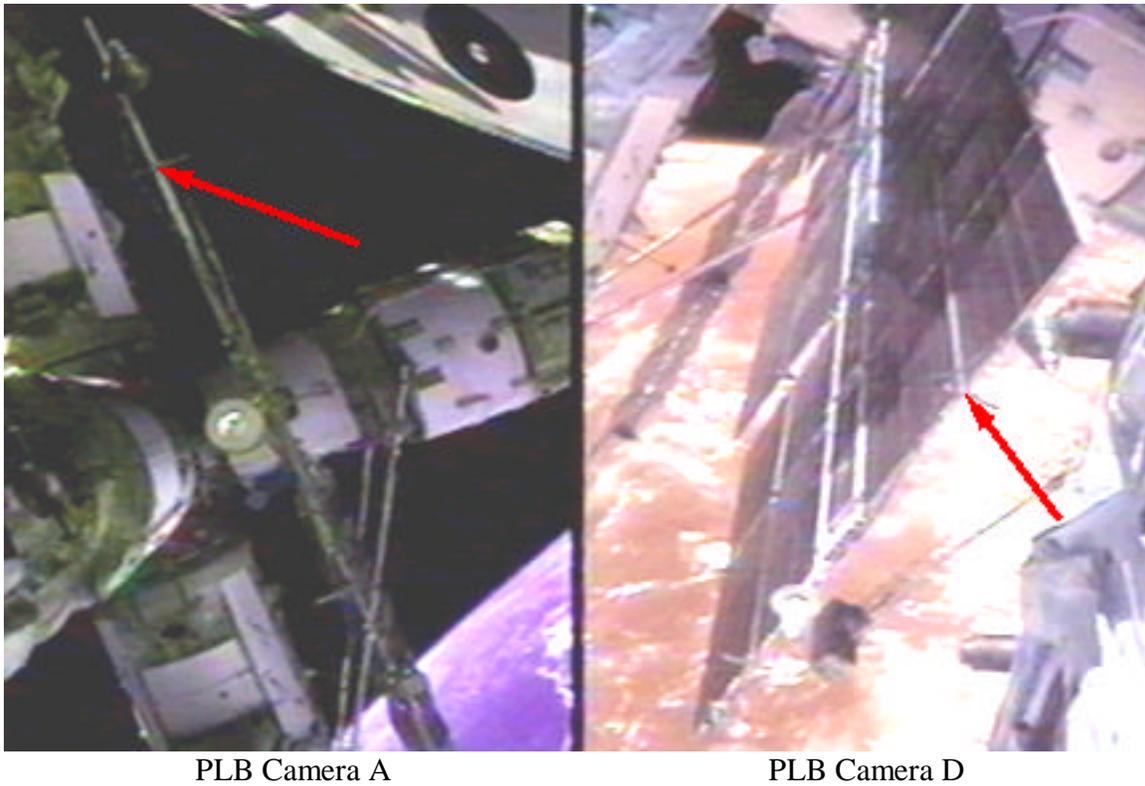
Figure 5.1 A Multiplexed Video Frame Used in the Motion Analysis of Base Block SP#2

During STS-84, video data of the motion of Base Block SP#2 during four controlled thruster firing sequences from the Shuttle was acquired. A table of the firings is shown in Table 5.1. Only test sequence #2 provided a detectable motion in the video. One minute of Sequence #2 was selected for analysis of the array motion. This sequence of video was selected to encompass a time span prior to, during, and after the Mir thruster firing sequence based on the IRIG timing on the tape. A multiplexed video frame used in the analysis of the Base Block SP#2 motion is shown in Figure 5.1. The tracked point is labeled in the figure with an arrow.

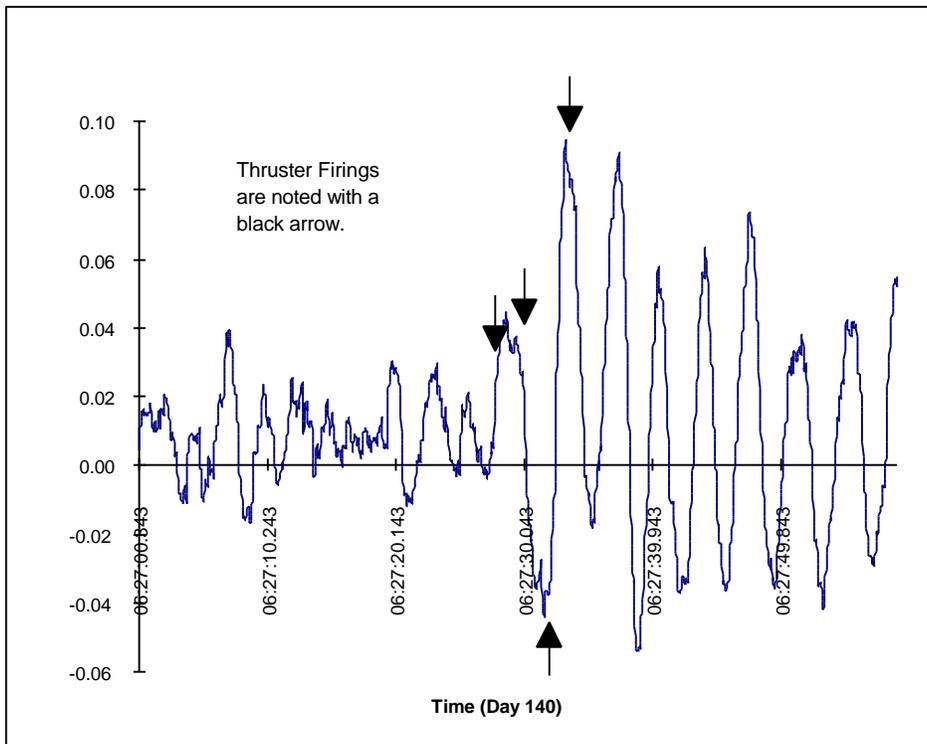
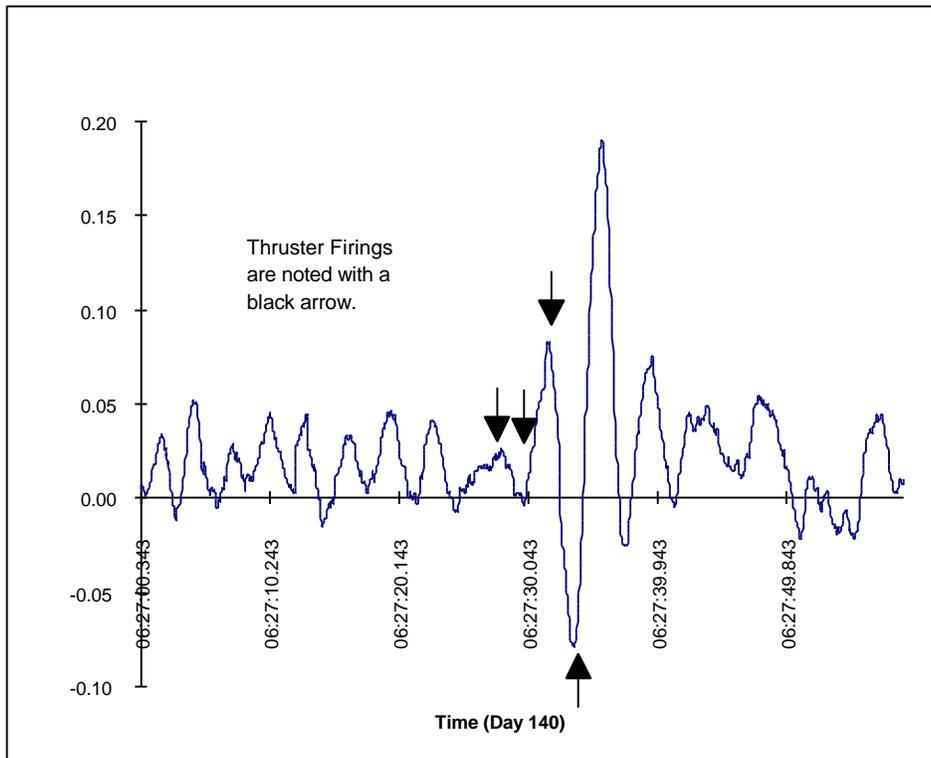
The results from the motion analyses are shown in Figures 5.2 and 5.3 for the out-of-plane and in-plane motions as a function of time. Thruster firings are noted with black arrows. To reduce the effect of high frequency noise in the measurements of the deflection of the solar panel, a moving average over 15 frames of the deflection data was calculated starting approximately 25 seconds before the first thruster firing to approximately 25 seconds after the last thruster firing. The peak-to-peak deflections were approximated from these smoothed curves as 0.14 ± 0.10 inches for out-of-plane motion and 0.27 ± 0.07 inches for in-plane motion. These results are representative of the thruster firings which are in the yaw direction, which would be expected to create larger motion in-plane relative to out-of-plane motion. In addition, the small magnitude of deflection was consistent with the visual examination of the video which showed only a barely perceptible motion when the video was played at three times normal speed.

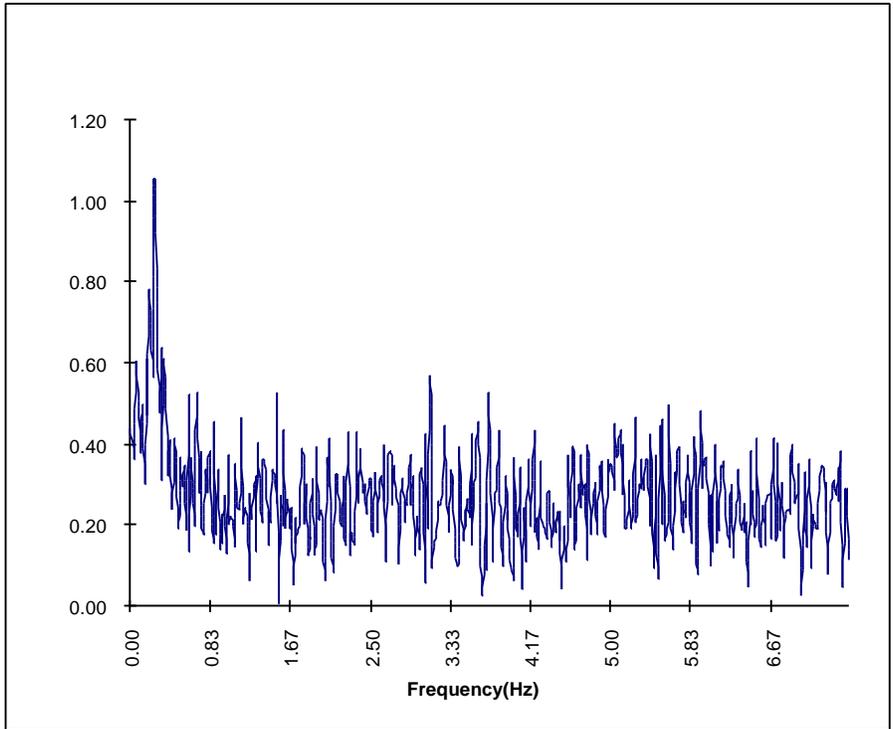
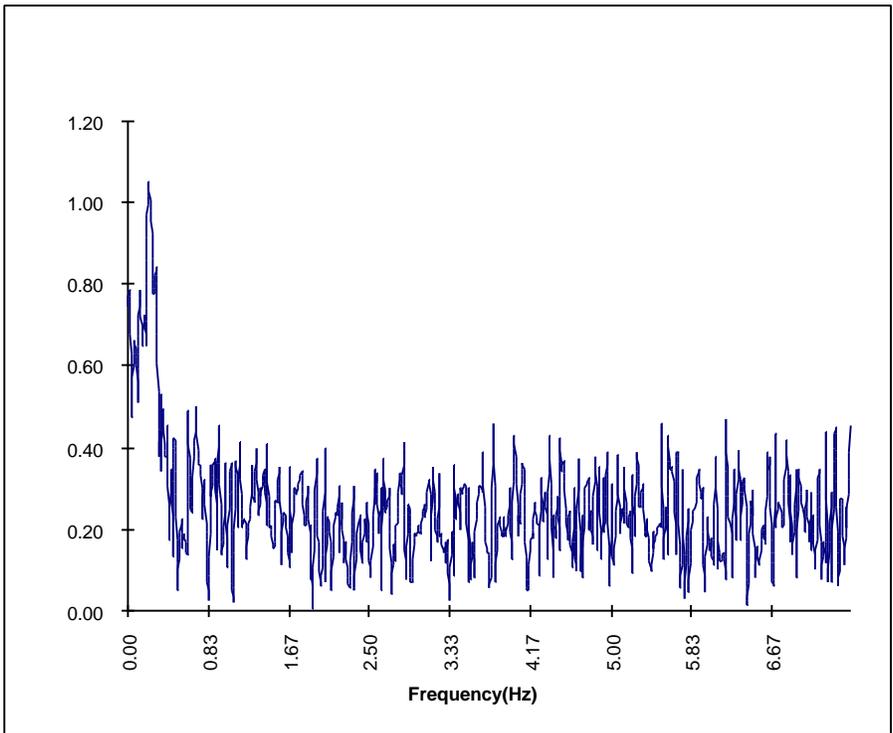
A Fast Fourier Transform (FFT) was applied to determine the dominant frequency. The graphs of the FFT's for the out-of-plane and in-plane data are shown in Figures 5.4 and 5.5. To emphasize the frequency of the motion and remove the frequency data associated with the sampling rate of the data, a small section of the Fourier transformed data is plotted. The dominant frequency for the in-plane motion is approximately 0.24 Hz and approximately 0.27 Hz for the out-of-plane motion.

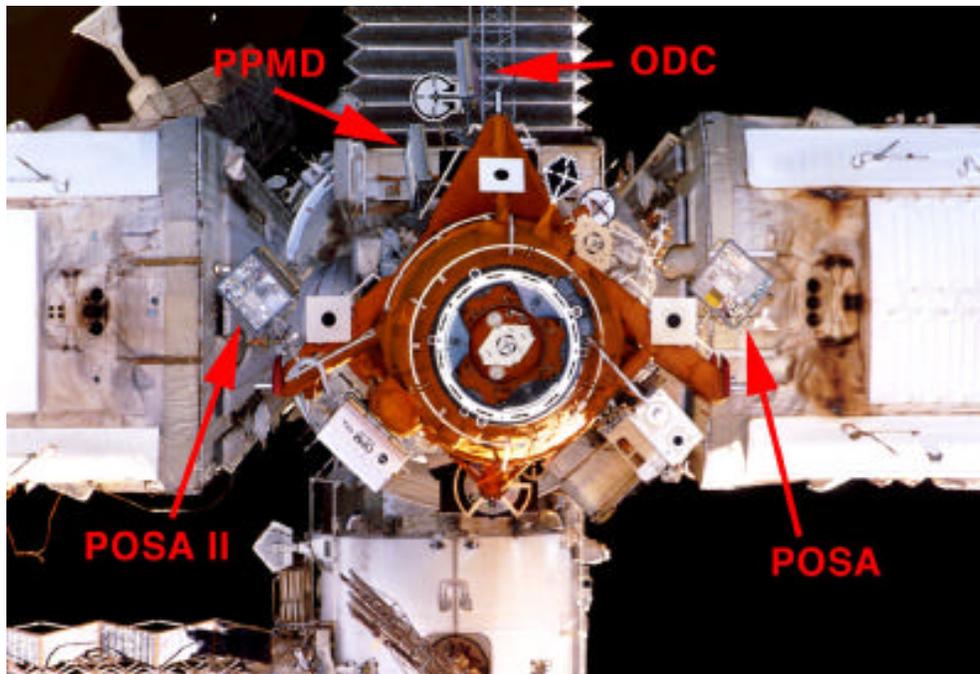
Figure 7.1. STS-84 Image of Mir with MEEP Experiments

Figure 7.1 is an image of the Docking Module with MEEP experiment panels identified. The image was obtained during approach to Mir by the Orbiter using the 35 mm camera with 400 mm lens. This image and the image in Figure 7.2 shows the four panels to be in good condition. Comparisons with STS-76 images show the panels to be in their original installed orientations.

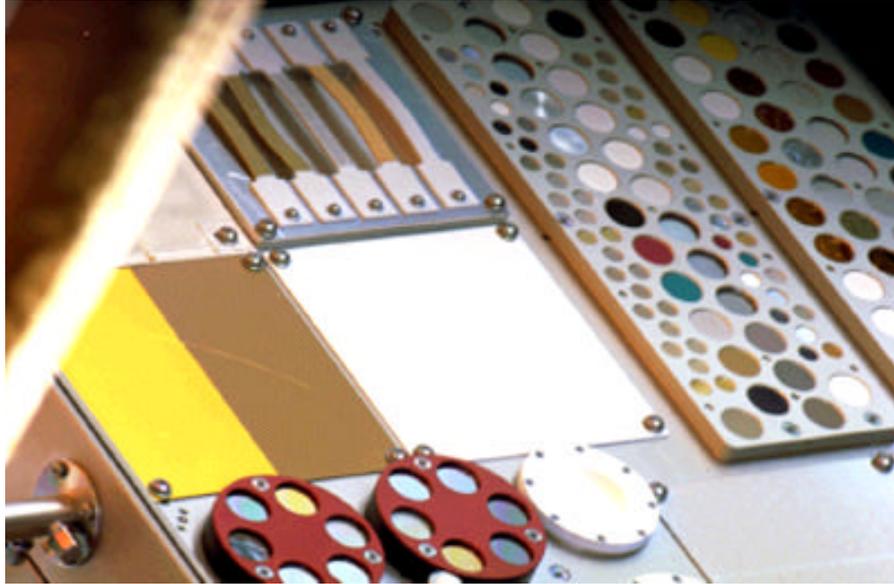
Figure 7.2 Image of POSA Acquired from Aft Flight Deck Window

Figures 7.2, 7.3, and 7.4 provide the highest quality images of the four MEEP experiments obtained on STS-84. The images have been digitally modified to the scale shown. There are no apparent damage or discolorations of any of the MEEP panels. Figure 7.2 is one of a set of images of POSA taken with the 35 mm camera and telephoto lens from the aft flight deck window. A small scratch which may be observed on the left two sections is attributed to a scratch on the film. Figure 7.3 shows the panels on both sides of POSA II. POSA II is the only experiment for which imagery was obtained of both sides of the experiment. The image on the left of Figure 7.3 (the POSA II side with the handle) was obtained with the 35 mm camera from the Spacehab window. The image on the right side was obtained during approach for docking. Both images are subsets from the original 35 mm frames. Figure 7.4 shows images of ODC and PPMD. The

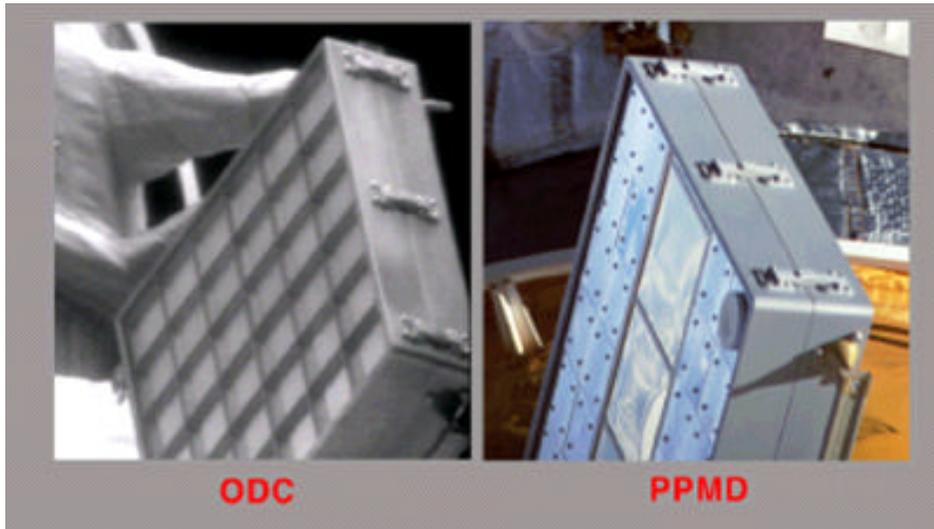
Figure 7.4 Images of ODC and PPMD

image of PPMD was also taken from the Spacehab window and is the clearest image of PPMD obtained on any of the missions to date. The image of the ODC was acquired with the monochrome PLB camera B.

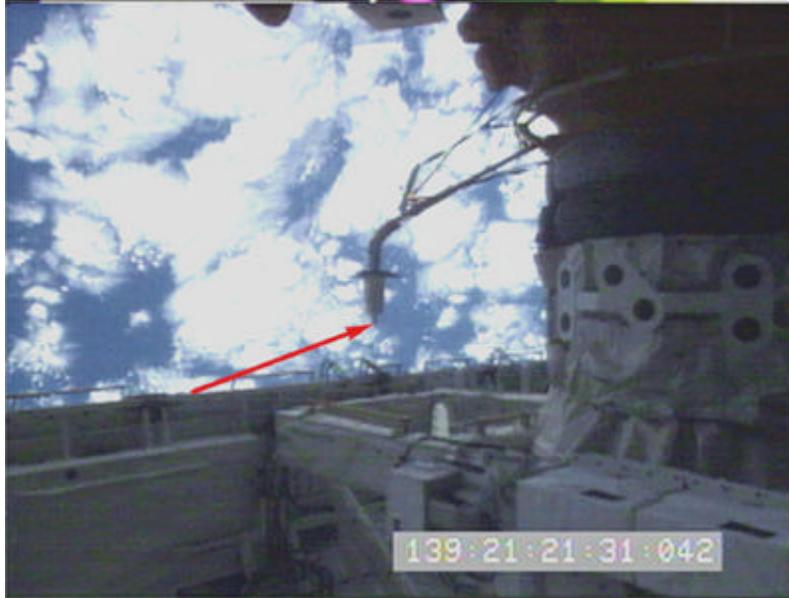
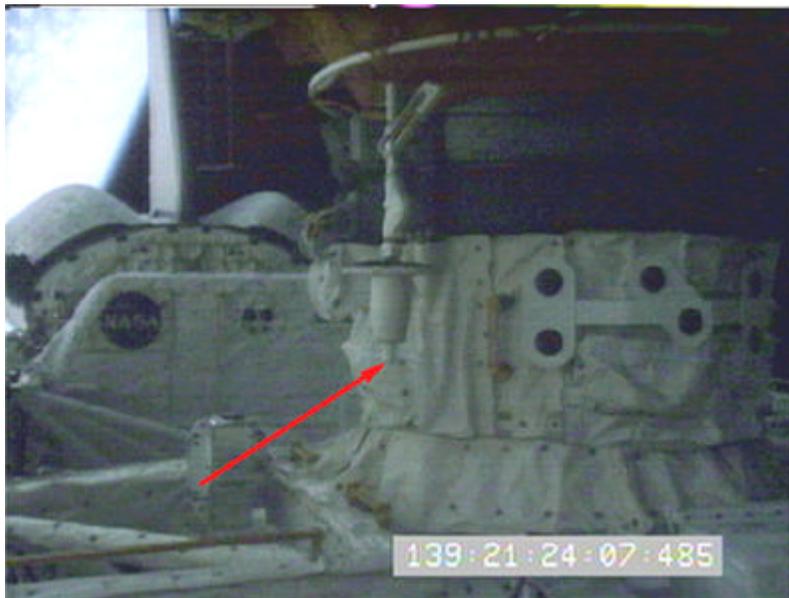
Two STS-84 video images from Shuttle PLB cameras A and D were used in this analysis. These two images are shown as Figures 8.2 and 8.3, respectively. The ODS targets of the Orbiter Space Vision System (OSVS) were used to establish the camera pointing angles.

84 analyses are accompanied by an uncertainty estimate derived from a standard Monte Carlo error estimator. Both the STS-84 and STS-81 results indicate a clearance of 109 inches between the tip of the antenna and the Shuttle forward bulkhead.
